# 技術基準適合確認書

製品名称	デジタルルームミラー
製品型番	MDR-PRO2、MR-PRO
試験分類	衝撃テスト
試験設備機器	インパクト試験機 GZST/YQ-DJ-22
試験委託機関	Guangzhou Shuntai Quality Technical Service Co., Ltd.
適用技術基準	ECE R46 6.3.2 衝撃テスト
試験結果	合格
試験成績書	委託試験成績書番号 SQT2511044
確認書発行元 (試験委託者)	昌騰有限会社 〒595-0023大阪府泉大津市豊中町2-3-35

# TEST REPORT

Product Name : Digital Room Mirror

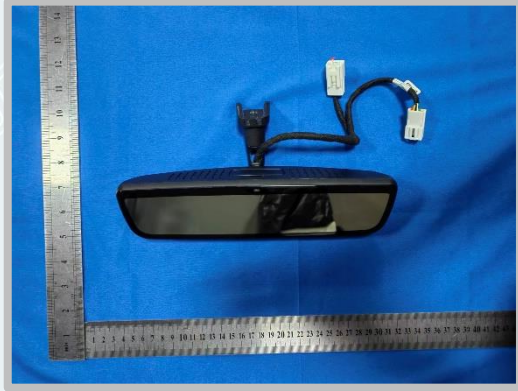
Before test- Front

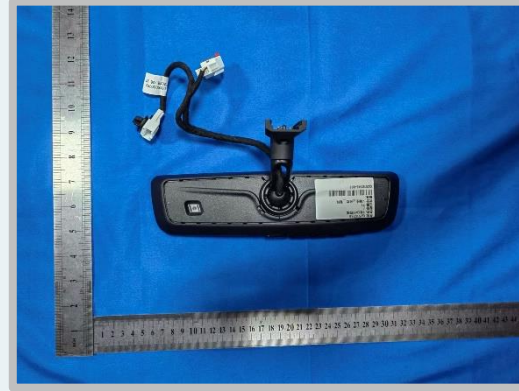
Before test- Back

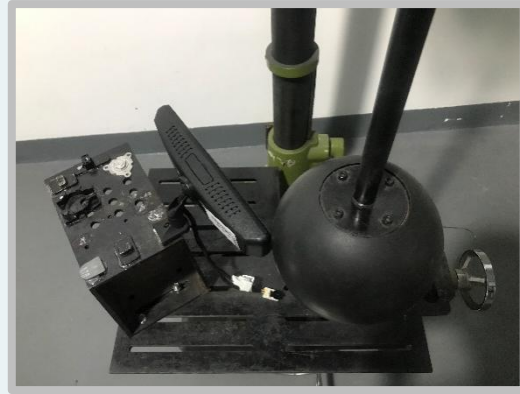
45° impact edge point

Test criteria:	UN R.46-06 series in paragraphs 6.3.2	
Test conditions:	Test	Test 1: The points of impact shall be as defined in paragraph 6.3.2.2.3. above. The impact shall be such that the hammer strikes the mirror on the reflecting surface side.
		Test 2: Point of impact on the edge of the protective housing, such that the impact produced makes an angle of 45° with the plane of the reflecting surface and is situated in the horizontal plane passing through the centre of that surface. The impact shall occur on the reflecting surface side.
Sample State When Testing:	Without cable harness	
Sample Quantity:	1 PCS	
Sample No.:	Q2510145-001	
Test Result/ Criteria:	<p>a) The part remaining shall not project beyond the base by more than 10 mm and the configuration remaining after the test shall satisfy the conditions laid down in paragraph 6.1.1.3. of this Regulation.</p> <p>b) The reflecting surface does not break or the fragments of glass still adhere to the protective housing or does not exceed 2,5 mm either side of the crack.</p> <p>c) The reflecting surface is made of safety glass.</p> <p>d) When performing a crash test, the pendulum should be able to continue to swing more than 20° in the release plane of the swingarm after impact.</p>

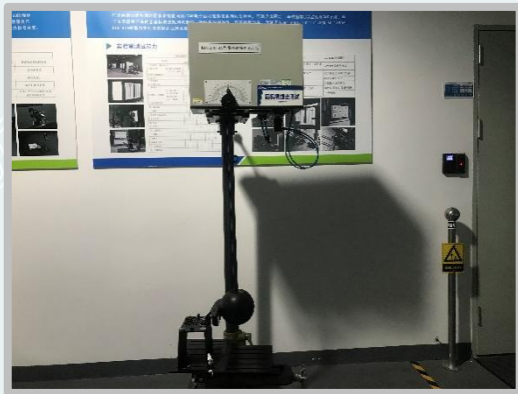
During test

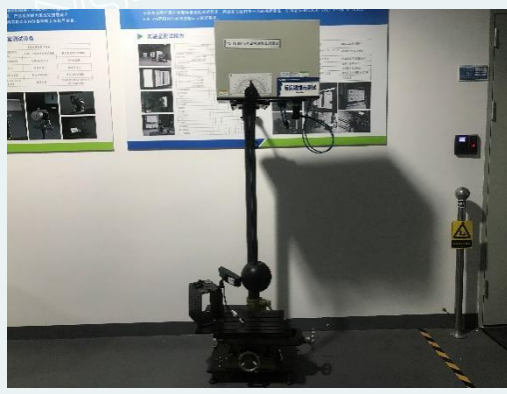
During test

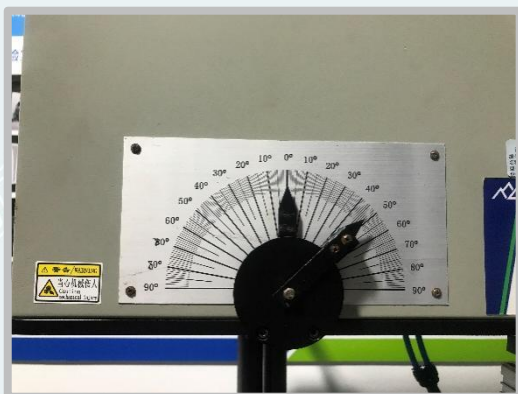
Angle after test - 48°

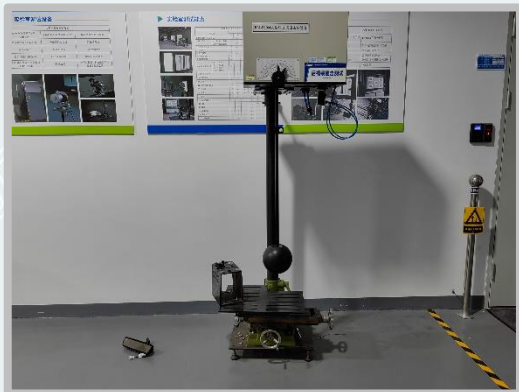
After test  
(It fell off on impact, mirror intact)

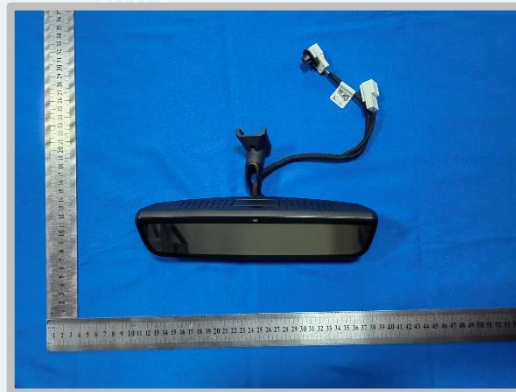
After test  
(The reflecting surface is not break)
