技術基準適合確認書

TEST REPORT

Product Name: Digital Rear-view Mirror

Test Standard(s): **UN R.046-Supplement 8 to the 04 series**

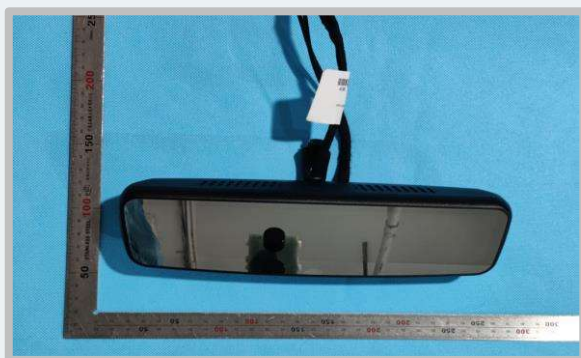
Fig. 1-1 Check before test-1#

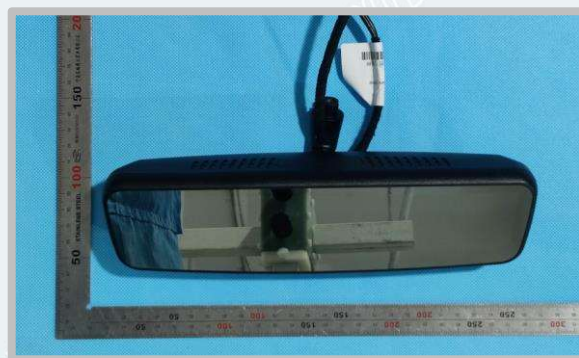
Fig. 1-2 Check before test-2#

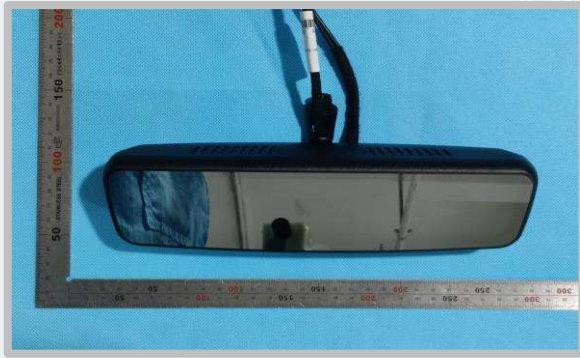
Fig. 1-3 Check after test-1#

Test Item	Judgment and Requirements		Results	
			Sample 1#	Sample 2#
Impact test	The pendulum shall continue to swing after impact in such a way that the projection of the position assumed by the arm on the plane of release makes an angle of at least 20° with the vertical.	Test 1	34.5°	30.5°
		Test 2	24°	22°
	The reflecting surface shall be free from breakage after the test.	Test 1	The reflecting surface is not	The reflecting surface is not
		Test 2	breakage after the test	breakage after the test

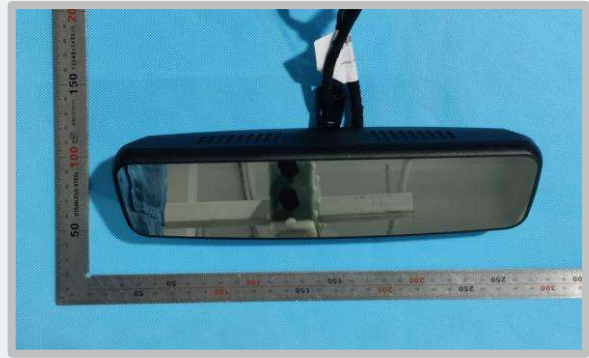
Fig. 1-4 Check after test-2#

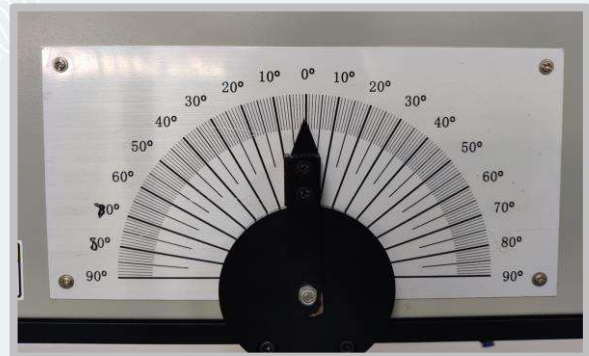
Fig. 1-6 Angle before test 2

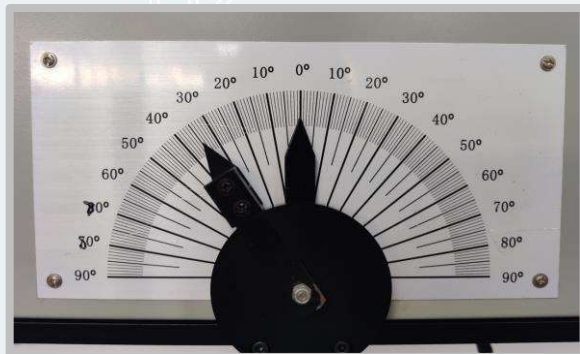
Fig. 1-7 Angle after test 1 -1#

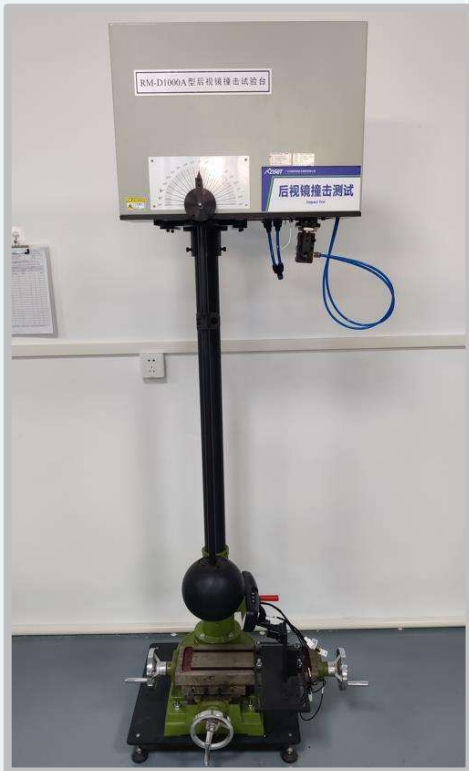
Fig. 1-11 Test 1 during test

(a) Test 1: The points of impact shall be as defined in paragraph 6.3.2.2.3. above. The impact shall be such that the hammer strikes the mirror on the reflecting surface side.

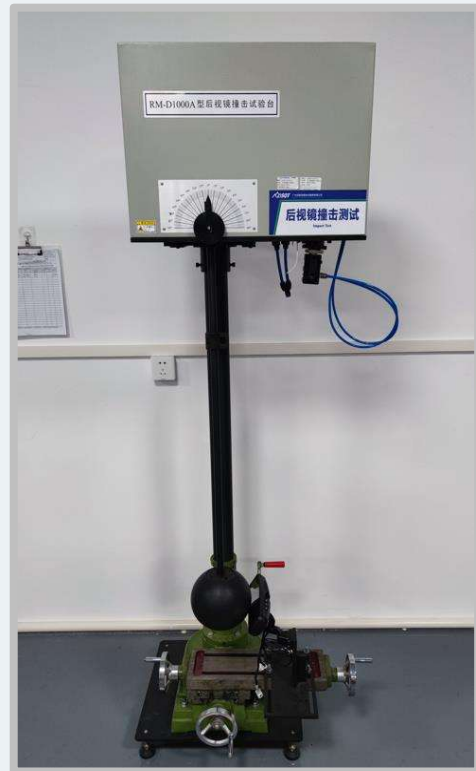
Fig. 1-12 Test 2 during test

(b) Test 2: Point of impact on the edge of the protective housing, such that the impact produced makes an angle of 45° with the plane of the reflecting surface and is situated in the horizontal plane passing through the centre of that surface. The impact shall occur on the reflecting surface side.
